# AUXILIARY EQUIPMENT FOR WORKING AT HEIGHTS: WORKERS' PERCEPTION OF SAFETY ISSUES

Valderrama-Ulloa Claudia<sup>1</sup>, Ferrada Ximena<sup>1</sup>, San Martín Tamara<sup>1</sup>, Cabello María – José<sup>1</sup>

<sup>1</sup> Centro de Investigación en Tecnologías para la Sociedad, Facultad de Ingeniería, Universidad del Desarrollo, Santiago, Chile

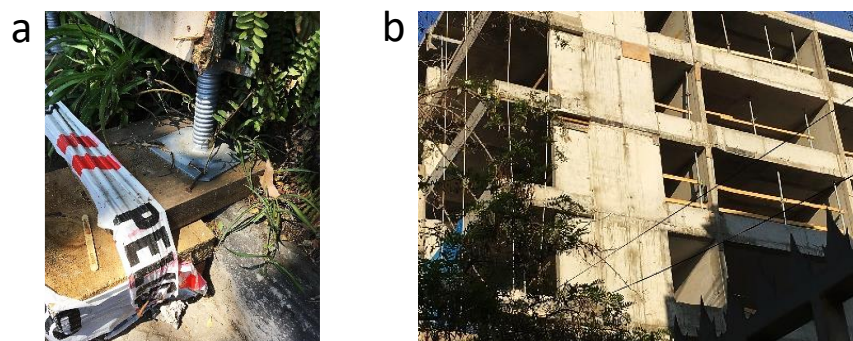
Fig. 1. (a) first picture; (b) second picture. (CCC-caption style)

Field observation of the use of scaffolding and guardrails showed that three major safety problems cause falls: human factors, environmental factors and technical aspects. Regarding human factors, the worker performs improper actions such as: (1) loosening or not using the lifelines, (2) not using all the safety elements or misusing them, (3) climbing the scaffolding structure or leaning on the railings, (4) not respecting the instructions of direct supervisors or risk prevention specialist, (5) not analyzing or observing the conditions of the task and possible risks, and (6) lacking or non-using work procedures. The environmental aspects are mainly related to the climatic conditions of the place where the work is performed, such as gusts of wind that cause the platform to sway, rain that makes the platform slippery, or glare from the sun, which interferes with the tasks. Concerning the technical aspects, there was a lack or absence of elements, such as (1) perimeter railings or structure fastening elements (Fig 1b), (2) accessories that ensure the balance, position and fixation of the structure or that ensure the vertical movement of the structure or brake, (3) scaffolding in poor condition, with wear and tear or structures that are not calculated (or poorly calculated), unstable, overloaded, with missing fastenings or incomplete (Fig. 1a), (4) incorrect assembly or insufficient working platforms.
